**Flood Control Project Maintenance
Levee Inspections**
LMA District Cover Sheet
Spring 2016 Levee Inspection Results

American River Flood Control District

Spring 2016 Levee Inspection Results

Waterway			Bank	Unit Miles
Unit No. 01 Arcade Creek			Left	2.08
	Spring (March - May)	Summer (June - August)	(September - November) Fall	Winter (December - February)
Unit Maintenance Rating (Fall Only)				
Date of Inspection	3/2/2016 - 3/2/2016			
DWR Inspector	Maksim Khashchuk			
Accompanied By	Richard Marck ARFCD			
	Sterling York

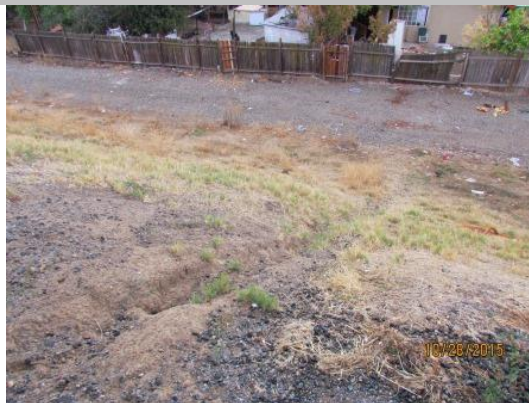
Photo 1 of 1 : SP_2016_NA0001_51_81_20160229_00038.jpg

LM Start	0.46	Rating **	M	Issue No.	81
LM End	0.46	Issue Type +	Ma	Location *	LS
Category	Earthen Levee			GPS Latitude/Longitude	
				Start	End
Item	Slope Stability			38.623101°	38.623101°
				-121.460573°	-121.460573°
DWR ID	DWR_NA0001_01_f_2015_81				
Comment Code					
S2 : Repair the levee slope damaged by foot traffic and prevent access where possible.					
Inspector Comment

View of the landside levee slope damaged by foot traffic.

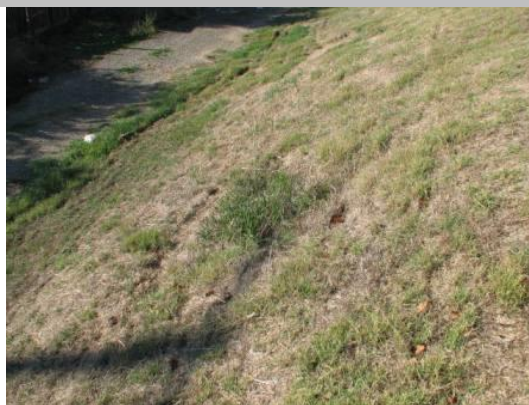
Photo 1 of 2 : SP_2016_NA0001_51_164_20160229_00039.jpg

LM Start	0.48	Rating **	A/W	Issue No.	164
LM End	0.48	Issue Type +	Ma	Location *	LS
Category	Earthen Levee			GPS Latitude/Longitude	
				Start	End
Item	Erosion / Bank Caving			38.623227 °	38.623227 °
				-121.460399 °	-121.460399 °
DWR ID	DWR_NA0001_01_s_2012_164				
Comment Code					
E1 : Note and monitor erosion site.					
Inspector Comment					
4'-5' diameter by 1' deep hole mid-slope on the landside.

11/17/2011 Hole/depression approximately mid-slope.

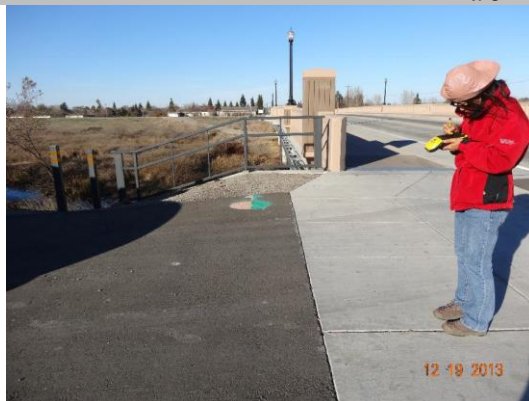
Photo 2 of 2 : UCIP_SP_2016_31167_57041.jpg

LM Start	0.66	Rating **	U	Issue No.	187 (cont)
LM End	0.66	Issue Type +	En	Location *	LS
Category	Supplemental			GPS Latitude/Longitude	
				Start	End
Item	DWR UCIP Field Study			38.623667 °	38.623667 °
				-121.457134 °	-121.457134 °
DWR ID					
Comment Code					
Inspector Comment					
FS_ID:31167 DS_ID:24266 EP_NO: 3417 Repair Type: Urgent Crossing Status: Found UCIP Comments: no markers visible on waterward or landward side indicating this is a gas line--need to contact owner to determine if this crossing is gas line. FIELD_STRUCT_DESC: 4-inch steel gas line through the levee, 1.5 feet below the crown. Corrugated metal (CM) cutoff wall around pipe at center of levee. Pump hung on bridge for channel crossing. (Permit No. 3417-1961) FS Date: 12/19/2013

Paint on paved levee indicates crossing could be a storm drain.

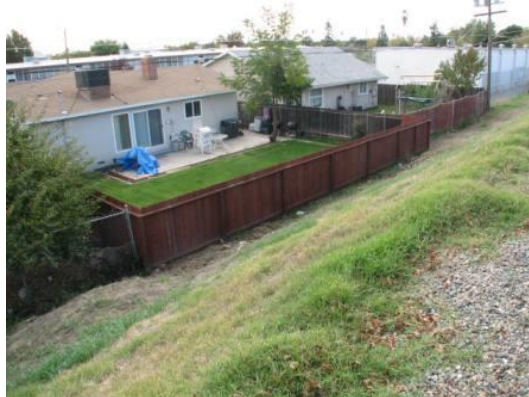
Photo 1 of 1 : SP_2016_NA0001_51_182_20160229_00050.jpg

LM Start	0.95	Rating **	U	Issue No.	182
LM End	0.95	Issue Type +	En	Location *	LS
Category	Earthen Levee			GPS Latitude/Longitude	
				Start	End
Item	Encroachments			38.625072 °	38.625072 °
				-121.452225 °	-121.452225 °
DWR ID	DWR_NA0001_01_s_2012_182				
Comment Code					
FE : Fence					
Inspector Comment					
Dog-eared wooden fence built within 10' of the toe.

11/17/2011 Wooden privacy fence built at the levee toe.

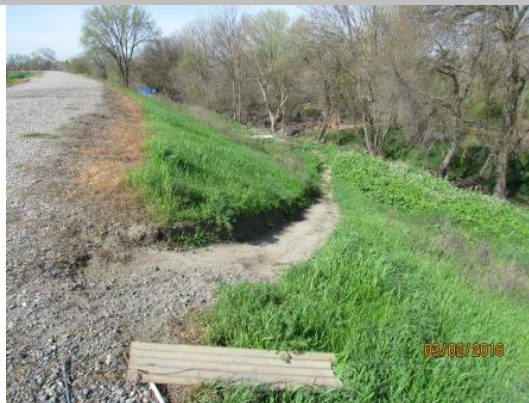
Photo 1 of 1 : SP_2016_NA0001_51_60_20160308_00092.jpg

LM Start	1.00	Rating **	M	Issue No.	60
LM End	1.00	Issue Type +	Ma	Location *	WS
Category	Earthen Levee			GPS Latitude/Longitude	
				Start	End
Item	Slope Stability			38.625161 °	38.625161 °
				-121.451302 °	-121.451302 °
DWR ID	DWR_NA0001_01_f_2015_60				
Comment Code					
S2 : Repair the levee slope damaged by foot traffic and prevent access where possible.					
Inspector Comment					
Backfill the cut made by the footpath.

View of the foot path on the waterside levee slope.

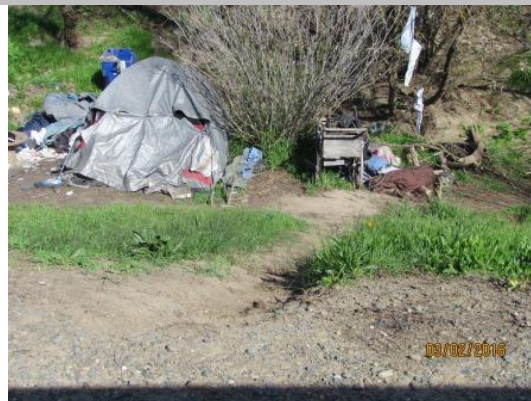
Photo 1 of 1 : SP_2016_NA0001_51_82_20160308_00089.jpg

LM Start	1.15	Rating **	A/W	Issue No.	82
LM End	1.15	Issue Type +	Ma	Location *	WS
Category	Earthen Levee			GPS Latitude/Longitude	
				Start	End
Item	Slope Stability			38.624866 °	38.624866 °
				-121.448555 °	-121.448555 °
DWR ID	DWR_NA0001_01_s _ 2016_82				
Comment Code					
S2 : Repair the levee slope damaged by foot traffic and prevent access where possible.					
Inspector Comment					
Homeless have created foot path.

View of the waterside levee slope erosion.

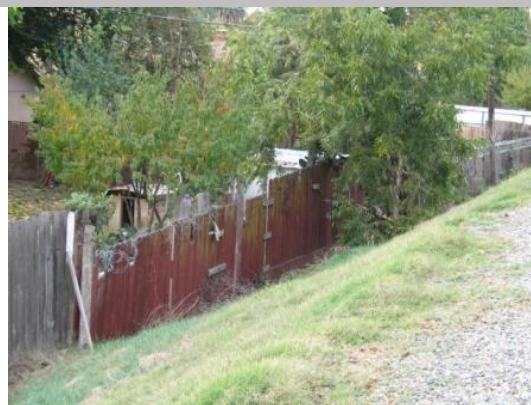
Photo 1 of 1 : SP_2016_NA0001_51_22_20160229_00019.jpg

LM Start	1.15	Rating **	U	Issue No.	22
LM End	1.15	Issue Type +	En	Location *	LS
Category	Earthen Levee			GPS Latitude/Longitude	
				Start	End
Item	Encroachments			38.624879 °	38.624879 °
				-121.448486 °	-121.448486 °
DWR ID	DWR_NA0001_01_s _ 2012_22				
Comment Code					
FE : Fence					
Inspector Comment					
Dog-eared wooden fence is built against the levee slope.

11/17/2011 Wooden privacy fence built at the levee toe.

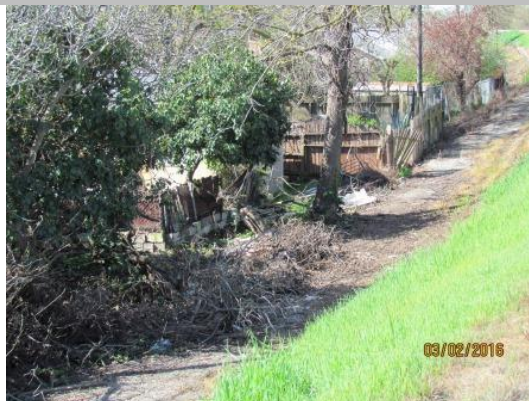
Photo 1 of 1 : SP_2016_NA0001_51_75_20160308_00091.jpg

LM Start	1.17	Rating **	M	Issue No.	75
LM End	1.17	Issue Type +	Ma	Location *	LS
Category	Earthen Levee			GPS Latitude/Longitude	
				Start	End
Item	Encroachments			38.624928 °	38.624928 °
				-121.448106 °	-121.448106 °
DWR ID	DWR_NA0001_01_f_2015_75				
Comment Code					
PR : Prunings					
Inspector Comment					
Tree trimmings and debris blocking visibility at LS toe.

View of the pile of prunings at the landside levee toe.

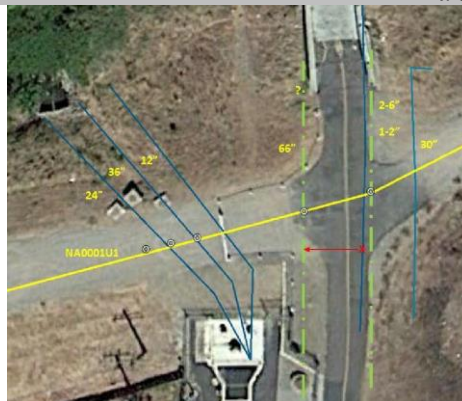
Photo 1 of 1 : UCIP_SP_2016_31178_57059.jpg

LM Start	1.22	Rating **	M	Issue No.	189
LM End	1.22	Issue Type +	En	Location *	LS
Category	Supplemental			GPS Latitude/Longitude	
				Start	End
Item	DWR UCIP Field Study			38.625117 °	38.625117 °
				-121.447318 °	-121.447318 °
DWR ID					
Comment Code					
Inspector Comment					
FS_ID:31178 DS_ID:24248 EP_NO: 14575 Repair Type: Non-Urgent Crossing Status: Not Found UCIP Comments: Crossing is present in the layer provided by the City of Sacramento, however this crossing was not found in the field. Need to determine status of crossing. If crossing is no longer used, owner will need to coordinate with Central Valley Flood Protection Board to comply with Title 23. FIELD_STRUCT_DESC: 30-inch concrete encased steel water main through the levee, 4.5 feet below the crown. Steel cutoff wall around pipe at center of levee. (Permit No. 14575-1988) FS Date: 12/19/2013

Alignment indicated in blue is approximate locations for pipes that cross levee. Alignment information was obtained from the City of Sacramento.

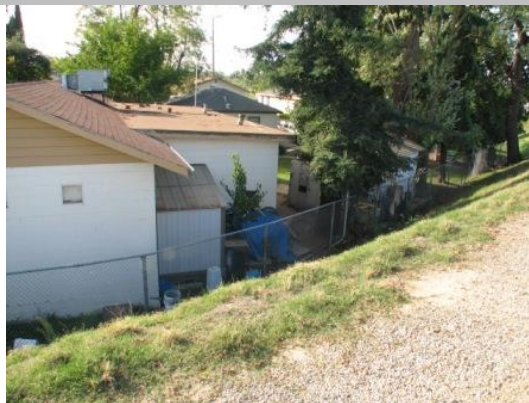
Photo 1 of 1 : SP_2016_NA0001_51_18_20160229_00016.jpg

LM Start	1.26	Rating **	U	Issue No.	18
LM End	1.26	Issue Type +	En	Location *	LS
Category	Earthen Levee			GPS Latitude/Longitude	
				Start	End
Item	Encroachments			38.625395 °	38.625395 °
				-121.446608 °	-121.446608 °
DWR ID	DWR_NA0001_01_s _ 2012_18				
Comment Code					
BU : Building					
Inspector Comment					
Cement block building within 10-ft of toe. Storage of equipment and supplies blocking visibility.

Fall 2009 photo: Buildings and fence near levee toe.

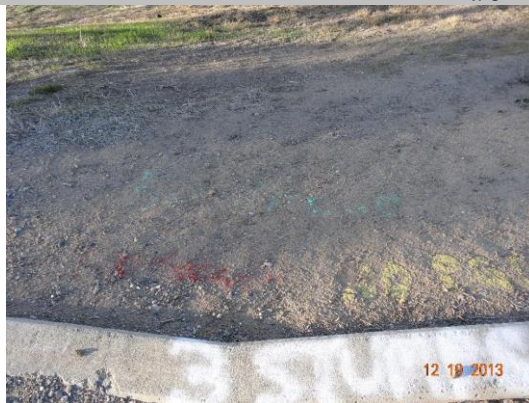
Photo 2 of 2 : UCIP_SP_2016_30085_55488.jpg

LM Start	1.28	Rating **	M	Issue No.	184 (cont)
LM End	1.28	Issue Type +	En	Location *	LS
Category	Supplemental			GPS Latitude/Longitude	
				Start	End
Item	DWR UCIP Field Study			38.625500 °	38.625500 °
				-121.446390 °	-121.446390 °
DWR ID					
Comment Code					
Inspector Comment					
FS_ID:30085 DS_ID:24576 EP_NO: N/A Repair Type: Non-Urgent Crossing Status: Indicator Found UCIP Comments: Unable to confirm location--will need to coordinate with owner to determine if crossing is still active and determine location. FIELD_STRUCT_DESC: 1 of 3: 16-inch pipe through the levee, 8.0 feet below the crown. Floodgates within the levee across the channel, installed under Permit No. 14480 (1986). FS Date: 12/19/2013

Underground service alert (USA) paint markings visible on waterward slope.

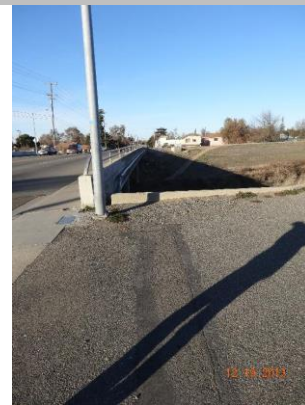
Photo 1 of 2 : UCIP_SP_2016_29734_54984.jpg

LM Start	1.30	Rating **	U	Issue No.	186
LM End	1.30	Issue Type +	En	Location *	LS
Category	Supplemental			GPS Latitude/Longitude	
				Start	End
Item	DWR UCIP Field Study			38.625603 °	38.625603 °
				-121.446035 °	-121.446035 °
DWR ID					
Comment Code					
Inspector Comment					
FS_ID:29734 DS_ID:24252 EP_NO: 15152 Repair Type: Urgent Crossing Status: Indicator Found UCIP Comments: Need to confirm if this crossing is gas line. Need to contact owner to determine status of crossing (active or inactive) and to determine last inspection date. Will need copy of letter showing crossings passed inspection. Missing utility markers. FIELD_STRUCT_DESC: 4-inch (appears to be 4.5 or 5 inches instead of 4 inches) steel gas main through the levee, 2.5 feet below the crown. Vent on the waterside (WS) shoulder. (Permit No. 15152-1989) FS Date: 12/19/2013

View of levee crown with repair signs at crossing.

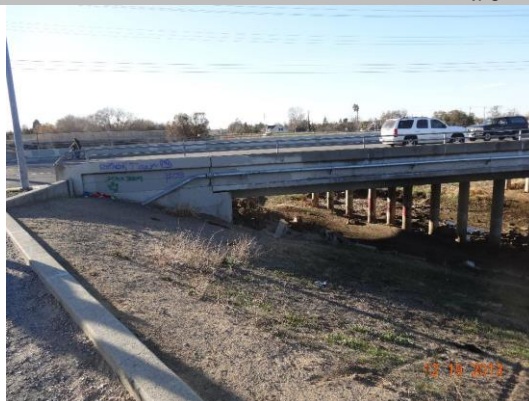
Photo 2 of 2 : UCIP_SP_2016_29734_54982.jpg

Item	DWR UCIP Field Study			38.625603 °		38.625603 °
				-121.446035 °		-121.446035 °
DWR ID						
Comment Code						
Inspector Comment						
FS_ID:29734						
DS_ID:24252						
EP_NO: 15152						
Repair Type: Urgent						
Crossing Status: Indicator Found						
UCIP Comments: Need to confirm if this crossing is gas line. Need to contact owner to determine status of crossing (active or inactive) and to determine last inspection date. Will need copy of letter showing crossings passed inspection. Missing utility markers.						
FIELD_STRUCT_DESC: 4-inch (appears to be 4.5 or 5 inches instead of 4 inches) steel gas main through the levee, 2.5 feet below the crown.						
Vent on the waterside (WS) shoulder. (Permit No. 15152-1989)						
FS Date: 12/19/2013

View of pipe across channel on the upstream face of bridge.

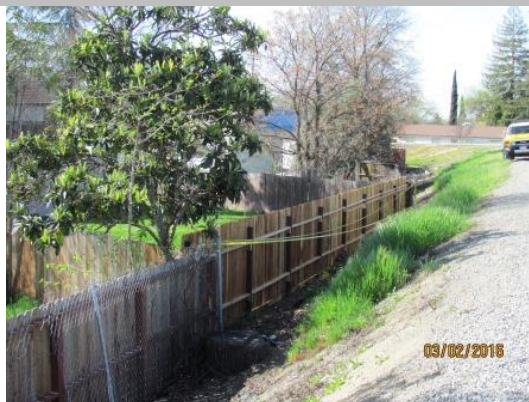
Photo 1 of 1 : SP_2016_NA0001_51_73_20160308_00087.jpg

LM Start	1.33	Rating **	U	Issue No.	73
LM End	1.33	Issue Type +	En	Location *	LS
Category	Earthen Levee			GPS Latitude/Longitude	
				Start	End
Item	Encroachments			38.625869 °	38.625869 °
				-121.445477 °	-121.445477 °
DWR ID	DWR_NA0001_01_f_2015_73				
Comment Code					
FE : Fence					
Inspector Comment					
Fence at LS toe.

View of the fence at the landside levee toe.

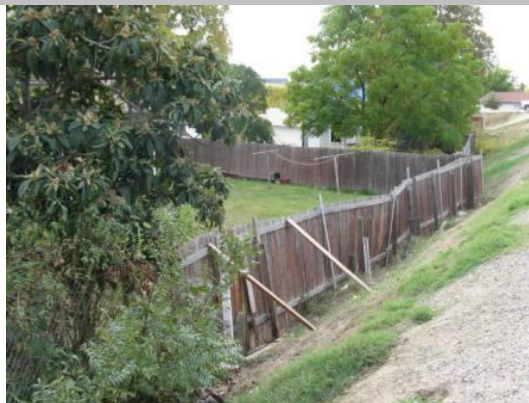
Photo 1 of 1 : SP_2016_NA0001_51_17_20160229_00015.jpg

LM Start	1.33	Rating **	U	Issue No.	17
LM End	1.33	Issue Type +	En	Location *	LS
Category	Earthen Levee			GPS Latitude/Longitude	
				Start	End
Item	Encroachments			38.625885 °	38.625885 °
				-121.445424 °	-121.445424 °
DWR ID	DWR_NA0001_01_s_2012_17				
Comment Code					
FE : Fence					
Inspector Comment					
Wooden privacy fence

11/17/2011 Wooden privacy fence built at the levee toe. Levee slope is being used to support the fence.

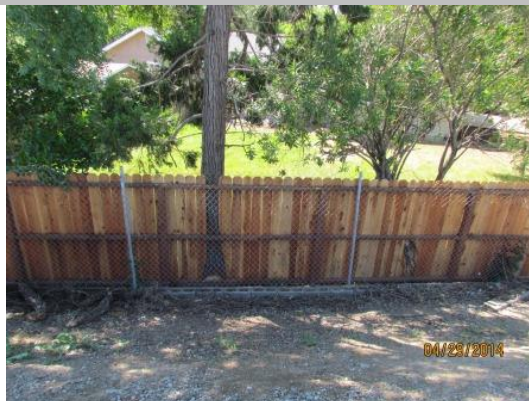
Photo 1 of 1 : SP_2016_NA0001_51_50_20160229_00032.jpg

LM Start	1.35	Rating **	U	Issue No.	50
LM End	1.35	Issue Type +	En	Location *	LS
Category	Earthen Levee			GPS Latitude/Longitude	
				Start	End
Item	Encroachments			38.625982 °	38.625982 °
				-121.445231 °	-121.445231 °
DWR ID	DWR_NA0001_01_s _ 2014_50				
Comment Code					
FE : Fence					
Inspector Comment

View of the fence at the landside levee toe obstructing visibility and access.

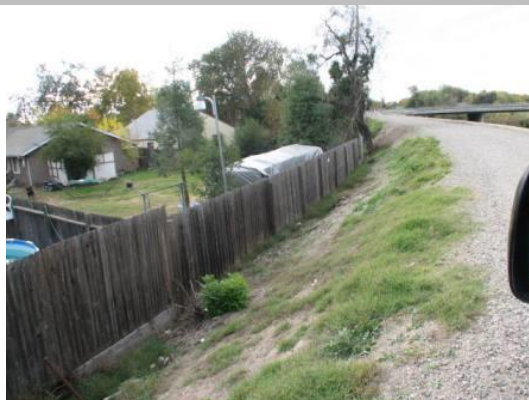
Photo 1 of 1 : SP_2016_NA0001_51_16_20160229_00014.jpg

LM Start	1.36	Rating **	U	Issue No.	16
LM End	1.36	Issue Type +	En	Location *	LS
Category	Earthen Levee			GPS Latitude/Longitude	
				Start	End
Item	Encroachments			38.626000 °	38.626000 °
				-121.444978 °	-121.444978 °
DWR ID	DWR_NA0001_01_s _ 2012_16				
Comment Code					
FE : Fence					
Inspector Comment					
Wooden privacy fence

11/17/2011 Wooden privacy fence built at the levee toe.

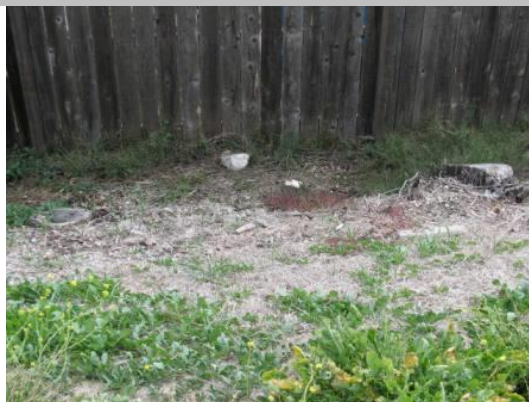
Photo 1 of 1 : SP_2016_NA0001_51_178_20160229_00049.jpg

LM Start	1.36	Rating **	N	Issue No.	178
LM End	1.36	Issue Type +	Ma	Location *	LS
Category	Earthen Levee			GPS Latitude/Longitude	
				Start	End
Item	Trim / Thin Trees			38.626063 °	38.626063 °
				-121.444988 °	-121.444988 °
DWR ID	DWR_NA0001_01_s _ 2012_178				
Comment Code					
T5 : Tree stumps.					
Inspector Comment					
Two stumps at landside toe.

11/17/2011 Two stumps at levee toe.

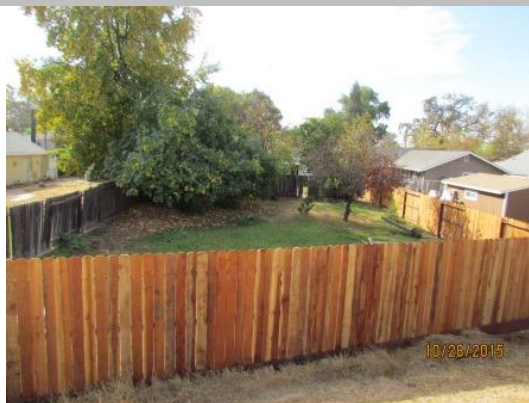
Photo 1 of 1 : SP_2016_NA0001_51_15_20160229_00013.jpg

LM Start	1.37	Rating **	U	Issue No.	15
LM End	1.37	Issue Type +	En	Location *	LS
Category	Earthen Levee			GPS Latitude/Longitude	
				Start	End
Item	Encroachments			38.626048 °	38.626048 °
				-121.444785 °	-121.444785 °
DWR ID	DWR_NA0001_01_s_2012_15				
Comment Code					
FE : Fence					
Inspector Comment					
Wooden privacy fence LS toe.

View of the fence at the landside levee toe.

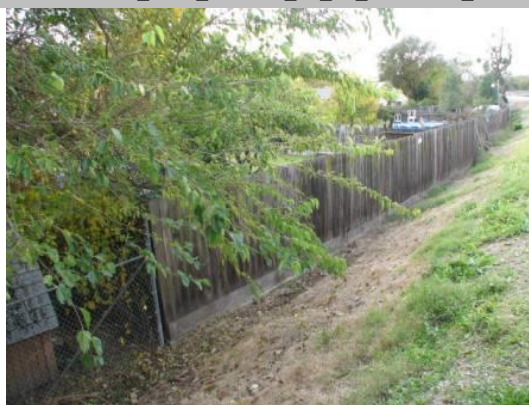
Photo 1 of 1 : SP_2016_NA0001_51_14_20160229_00012.jpg

LM Start	1.38	Rating **	U	Issue No.	14
LM End	1.38	Issue Type +	En	Location *	LS
Category	Earthen Levee			GPS Latitude/Longitude	
				Start	End
Item	Encroachments			38.626085 °	38.626085 °
				-121.444580 °	-121.444580 °
DWR ID	DWR_NA0001_01_s_2012_14				
Comment Code					
FE : Fence					
Inspector Comment					
Wooden privacy fence

11/17/2011 Wooden privacy fence built at the levee toe.

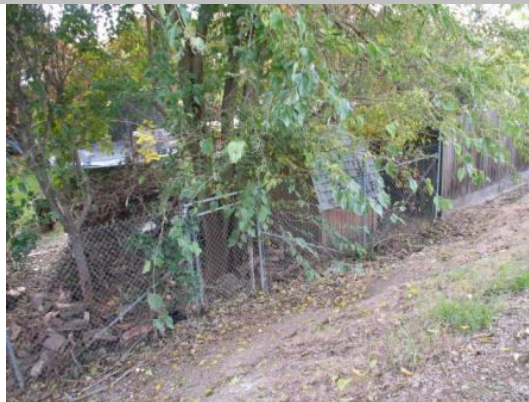
Photo 1 of 1 : SP_2016_NA0001_51_38_20160229_00028.jpg

LM Start	1.40	Rating **	M	Issue No.	38
LM End	1.40	Issue Type +	En	Location *	LS
Category	Earthen Levee			GPS Latitude/Longitude	
				Start	End
Item	Encroachments			38.626210 °	38.626210 °
				-121.444320 °	-121.444320 °
DWR ID	DWR_NA0001_01_s_2012_38				
Comment Code					
BU : Building					
Inspector Comment					
Small wooden storage shed and firewood are placed along chain link fence within 10-ft of levee toe.

11/17/2011 Shed and firewood can be seen through the chainlink fence.

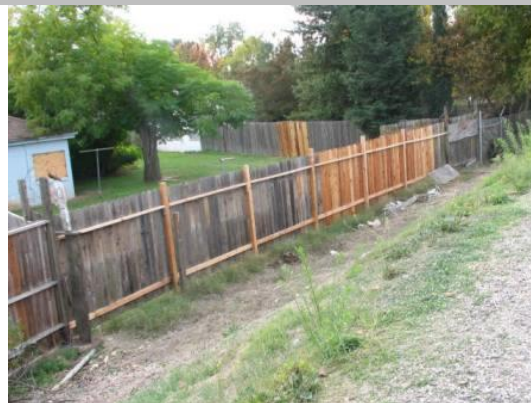
Photo 1 of 1 : SP_2016_NA0001_51_13_20160229_00011.jpg

LM Start	1.40	Rating **	U	Issue No.	13
LM End	1.40	Issue Type +	En	Location *	LS
Category	Earthen Levee			GPS Latitude/Longitude	
				Start	End
Item	Encroachments			38.626155 °	38.626155 °
				-121.444250 °	-121.444250 °
DWR ID	DWR_NA0001_01_s_2012_13				
Comment Code					
FE : Fence					
Inspector Comment					
Wooden fence with barbed wire is built within 10-ft of levee toe. 04/13/2011 Fence has blown over and now partially rests on the levee. Fall insp 2011 fence has been rebuilt in same location, within 10' of levee toe.

11/17/2011 New wooden privacy fence built within 15' of the levee toe.

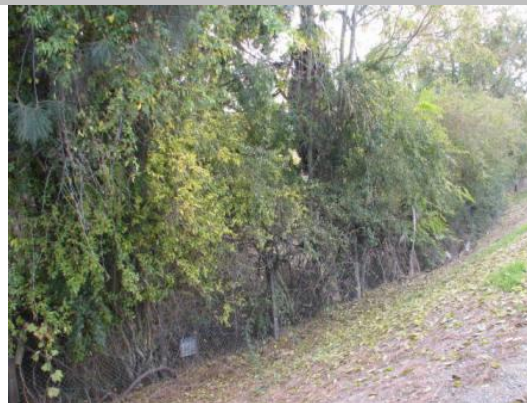
Photo 1 of 1 : SP_2016_NA0001_51_177_20160229_00048.jpg

LM Start	1.42	Rating **	U	Issue No.	177
LM End	1.42	Issue Type +	En	Location *	LS
Category	Earthen Levee			GPS Latitude/Longitude	
				Start	End
Item	Vegetation			38.626388 °	38.626388 °
				-121.443910 °	-121.443910 °
DWR ID	DWR_NA0001_01_s_2012_177				
Comment Code					
V6 : Landscaping					
Inspector Comment					
Thick vegetation at the toe.

11/17/2011 Thick vegetation at the levee toe.

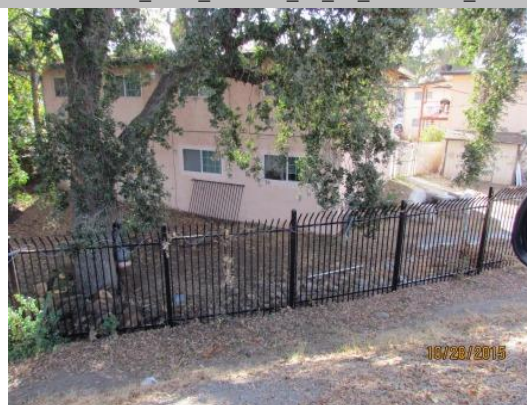
Photo 1 of 1 : SP_2016_NA0001_51_70_20160229_00036.jpg

LM Start	1.44	Rating **	U	Issue No.	70
LM End	1.44	Issue Type +	En	Location *	LS
Category	Earthen Levee			GPS Latitude/Longitude	
				Start	End
Item	Encroachments			38.626589 °	38.626589 °
				-121.443640 °	-121.443640 °
DWR ID	DWR_NA0001_01_f_2015_70				
Comment Code					
FE : Fence					
Inspector Comment					
Rought iron fence at LS toe blocks access.

View of the fence at the landside levee toe.

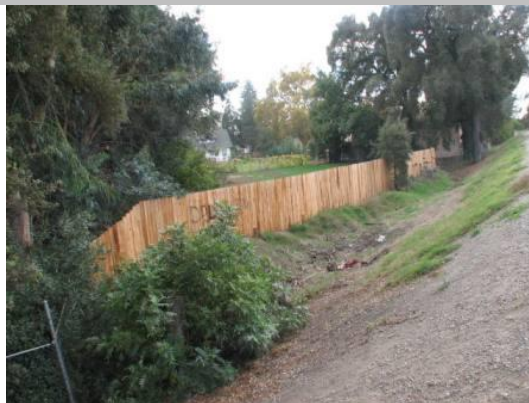
Photo 1 of 1 : SP_2016_NA0001_51_176_20160229_00047.jpg

LM Start	1.47	Rating **	A/W	Issue No.	176
LM End	1.47	Issue Type +	En	Location *	LS
Category	Earthen Levee			GPS Latitude/Longitude	
				Start	End
Item	Encroachments			38.626881 °	38.626881 °
				-121.443253 °	-121.443253 °
DWR ID	DWR_NA0001_01_s_2012_176				
Comment Code					
FE : Fence					
Inspector Comment					
Wooden privacy fence within 10' of the levee toe.

11/17/2011 Wooden privacy fence built within 15' of the levee toe.

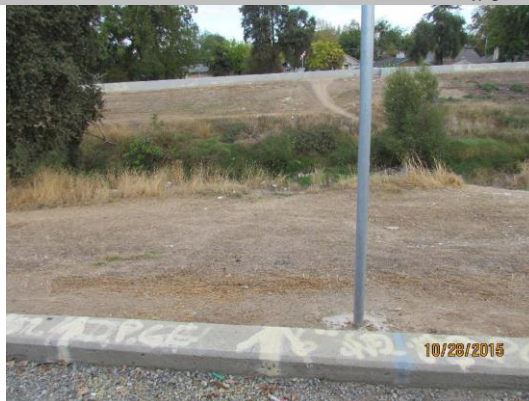
Photo 1 of 2 : UCIP_SP_2016_46793_74731.jpg

LM Start	1.57	Rating **	M	Issue No.	194
LM End	1.57	Issue Type +	En	Location *	LS
Category	Supplemental			GPS Latitude/Longitude	
				Start	End
Item	DWR UCIP Field Study			38.627277 °	38.627277 °
				-121.441650 °	-121.441650 °
DWR ID					
Comment Code					
Inspector Comment					
FS_ID:46793 DS_ID:24573 EP_NO: N/A Repair Type: Non-Urgent Crossing Status: Indicator Found UCIP Comments: 11/12/15 Markers have been installed on both levees--confirmed during DWR Fall Inspection. Need to coordinate with PG&E to determine permit for this crossing.12/19/13 No markers visible indicating crossing through levee. PG&E line. Need to coordinate with owner. Permit? FIELD_STRUCT_DESC: 2 of 2: 6-inch pipe through the levee, at unknown depth and goes under the channel. FS Date: 11/12/2015 1:52:00 PM

Markers installed on both levees in 2015.

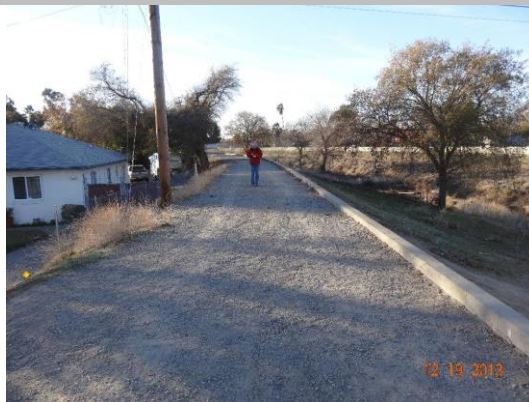
Photo 2 of 2 : UCIP_SP_2016_46793_57072.jpg

Overview of area near crossing. Inspector is standing where crossing goes through levee.

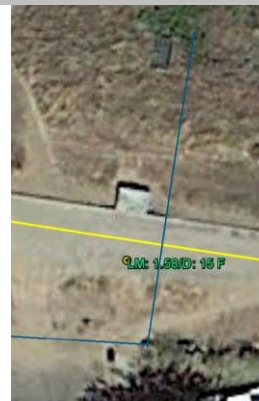
Photo 1 of 2 : UCIP_SP_2016_31182_57075.jpg

LM Start	1.58	Rating **	M	Issue No.	190
LM End	1.58	Issue Type +	En	Location *	LS
Category	Supplemental			GPS Latitude/Longitude	
				Start	End
Item	DWR UCIP Field Study			38.627241 °	38.627241 °
				-121.441465 °	-121.441465 °
DWR ID					
Comment Code					
Inspector Comment					
FS_ID:31182 DS_ID:24255 EP_NO: N/A Repair Type: Non-Urgent Crossing Status: Found UCIP Comments: 1/29/14 1/29/14 approximate alignment of crossings was provided by the City of Sacramento for known crossings through levee. Unable to confirm last inspection. Also City records indicate 24-inch CMP not 15-inch--need to clarify with owner. Crossing is operational. FIELD_STRUCT_DESC: 15-inch pipe through the levee, 8.5 feet below the crown. Flap gate on the waterside (WS) end. FS Date: 12/19/2013

Alignment in blue is an estimate of pipe alignment provided by the City of Sacramento. The symbol at LM 1.58 is field confirmed location.

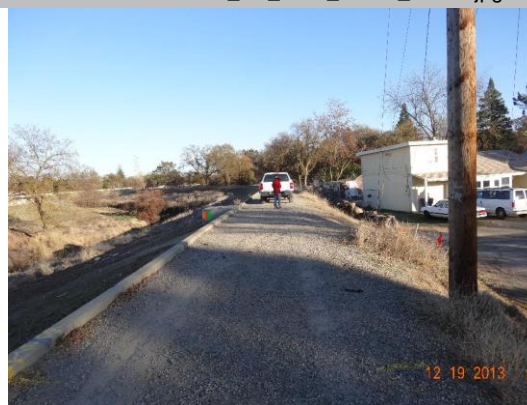
Photo 2 of 2 : UCIP_SP_2016_31182_57076.jpg

Overview of levee at crossing.

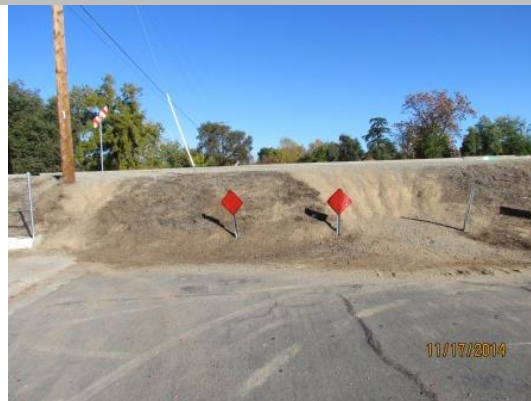
Photo 1 of 1 : SP_2016_NA0001_51_54_20160229_00033.jpg

LM Start	1.58	Rating **	A/W	Issue No.	54
LM End	1.58	Issue Type +	Ma	Location *	LS
Category	Earthen Levee			GPS Latitude/Longitude	
				Start	End
Item	Slope Stability			38.627251 °	38.627251 °
				-121.441460 °	-121.441460 °
DWR ID	DWR_NA0001_01_s_2012_54				
Comment Code					
S2 : Repair the levee slope damaged by foot traffic and prevent access where possible.					
Inspector Comment

Slope stability due to foot traffic needs to be monitored.

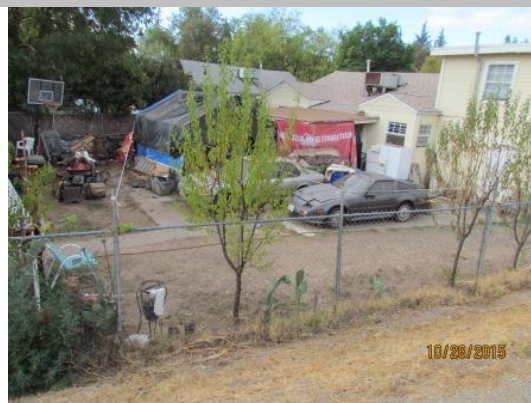
Photo 1 of 1 : SP_2016_NA0001_51_67_20160229_00035.jpg

LM Start	1.60	Rating **	M	Issue No.	67
LM End	1.60	Issue Type +	En	Location *	LS
Category	Earthen Levee			GPS Latitude/Longitude	
				Start	End
Item	Encroachments			38.627207 °	38.627207 °
				-121.441104 °	-121.441104 °
DWR ID	DWR_NA0001_01_f_2015_67				
Comment Code					
FE : Fence					
Inspector Comment					
Fence at landside levee toe. 6 fruit trees and various cactus plants at LS toe.

View of the fence and landscaping at the landside levee toe.

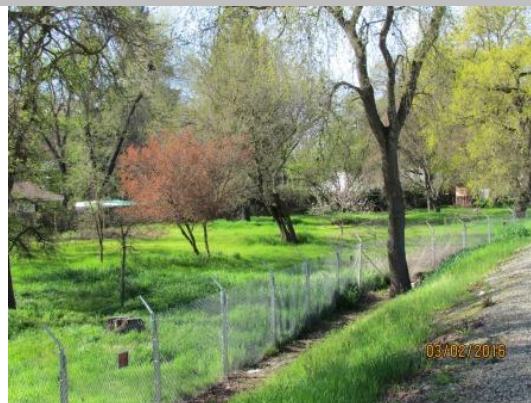
Photo 1 of 1 : SP_2016_NA0001_51_66_20160308_00086.jpg

LM Start	1.61	Rating **	M	Issue No.	66
LM End	1.68	Issue Type +	En	Location *	LS
Category	Earthen Levee			GPS Latitude/Longitude	
				Start	End
Item	Encroachments			38.627195 °	38.627500 °
				-121.440974 °	-121.439766 °
DWR ID	DWR_NA0001_01_f_2015_66				
Comment Code					
FE : Fence					
Inspector Comment					
Fence at landside levee toe.

View of the fence at the landside levee toe.

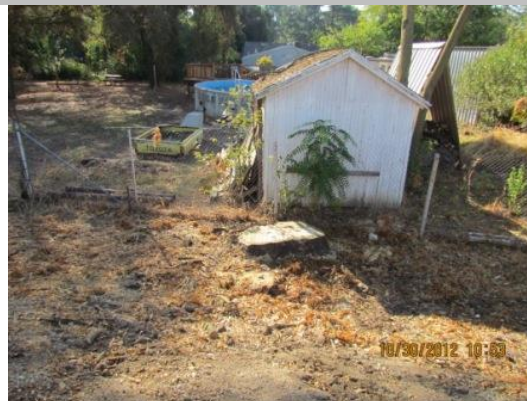
Photo 1 of 1 : SP_2016_NA0001_51_31_20160229_00025.jpg

LM Start	1.61	Rating **	N	Issue No.	31
LM End	1.61	Issue Type +	Ma	Location *	LS
Category	Earthen Levee			GPS Latitude/Longitude	
				Start	End
Item	Trim / Thin Trees			38.627191 °	38.627191 °
				-121.440861 °	-121.440861 °
DWR ID	DWR_NA0001_01_f_2012_31				
Comment Code					
T5 : Tree stumps.					
Inspector Comment

View of large tree stump at levee toe.

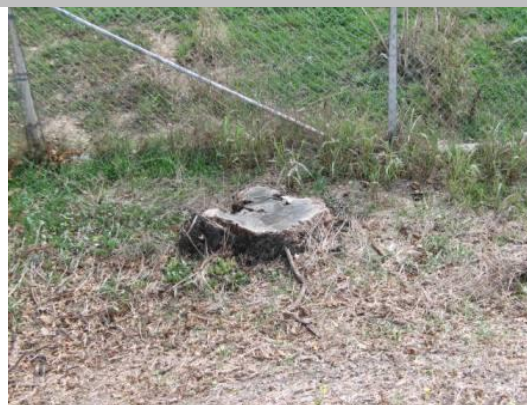
Photo 1 of 1 : SP_2016_NA0001_51_173_20160229_00046.jpg

LM Start	1.65	Rating **	U	Issue No.	173
LM End	1.65	Issue Type +	Ma	Location *	LS
Category	Earthen Levee			GPS Latitude/Longitude	
				Start	End
Item	Trim / Thin Trees			38.627297 °	38.627297 °
				-121.440188 °	-121.440188 °
DWR ID	DWR_NA0001_01_f_2015_173				
Comment Code					
T5 : Tree stumps.					
Inspector Comment					
Large stump at levee toe. Remove stump next construction season.

11/17/2011 Stump at levee toe.

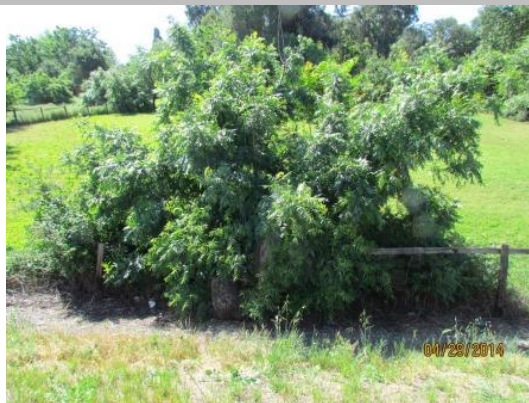
Photo 1 of 1 : SP_2016_NA0001_51_48_20160229_00031.jpg

LM Start	1.69	Rating **	M	Issue No.	48
LM End	1.69	Issue Type +	Ma	Location *	LS
Category	Earthen Levee			GPS Latitude/Longitude	
				Start	End
Item	Vegetation			38.627594 °	38.627594 °
				-121.439540 °	-121.439540 °
DWR ID	DWR_NA0001_01_s_2014_48				
Comment Code					
V2 : Remove the wild growth other than native grasses from the levee slopes.					
Inspector Comment					
Tree obstructing visibility and access.

View of the overgrown tree at the landside levee toe.

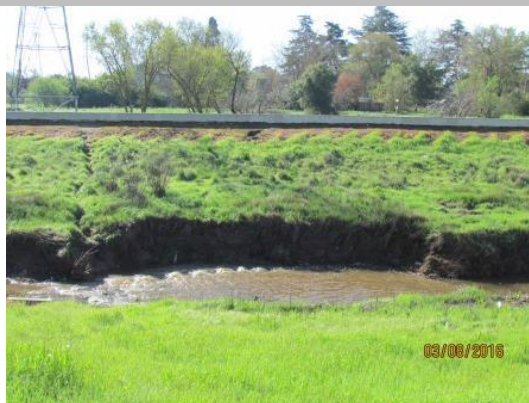
Photo 1 of 1 : SP_2016_NA0001_51_84_20160314_00093.jpg

LM Start	1.74	Rating **	A/W	Issue No.	84
LM End	1.74	Issue Type +	Ma	Location *	WS
Category	Earthen Levee			GPS Latitude/Longitude	
				Start	End
Item	Erosion / Bank Caving			38.627846 °	38.627846 °
				-121.438641 °	-121.438641 °
DWR ID	DWR_NA0001_01_s_2016_84				
Comment Code					
E1 : Note and monitor erosion site.					
Inspector Comment					
The LMA is making plans to repair this site soon.

View of the erosion on the waterside levee berm.

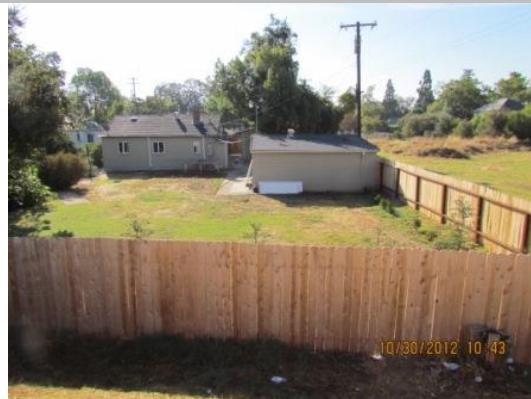
Photo 1 of 1 : SP_2016_NA0001_51_10_20160229_00009.jpg

LM Start	1.79	Rating **	U	Issue No.	10
LM End	1.79	Issue Type +	En	Location *	LS
Category	Earthen Levee			GPS Latitude/Longitude	
				Start	End
Item	Encroachments			38.627948 °	38.627948 °
				-121.437682 °	-121.437682 °
DWR ID	DWR_NA0001_01_f_2012_10				
Comment Code					
FE : Fence					
Inspector Comment					
Wooden fence constructed at LS levee toe.

View of new fence constructed at levee toe and 7 redwood trees planted behind fence within easement.

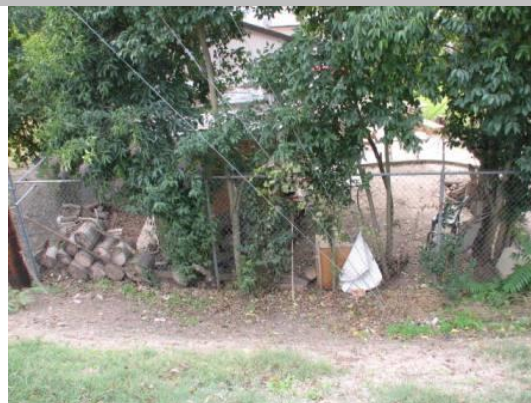
Photo 1 of 1 : SP_2016_NA0001_51_33_20160229_00026.jpg

LM Start	1.83	Rating **	U	Issue No.	33
LM End	1.83	Issue Type +	En	Location *	LS
Category	Earthen Levee			GPS Latitude/Longitude	
				Start	End
Item	Encroachments			38.627897 °	38.627897 °
				-121.437073 °	-121.437073 °
DWR ID	DWR_NA0001_01_s_2012_33				
Comment Code					
BU : Building					
Inspector Comment					
Wooden animal pen is built against levee slope.

11/17/2011 Wooden structure is built within 15' of the levee toe.

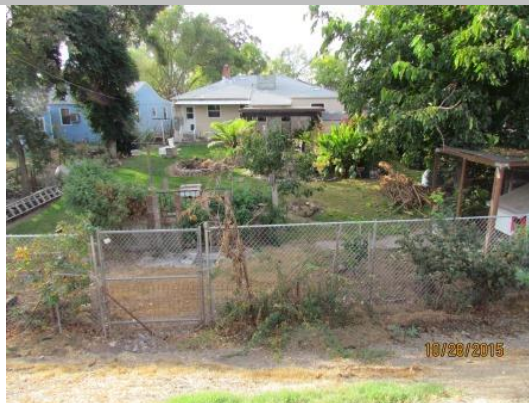
Photo 1 of 1 : SP_2016_NA0001_51_9_20160229_00008.jpg

LM Start	1.85	Rating **	M	Issue No.	9
LM End	1.85	Issue Type +	En	Location *	LS
Category	Earthen Levee			GPS Latitude/Longitude	
				Start	End
Item	Encroachments			38.627884 °	38.627884 °
				-121.436682 °	-121.436682 °
DWR ID	DWR_NA0001_01_s _ 2012_9				
Comment Code					
FE : Fence					
Inspector Comment

View of the fence at the landside levee toe.

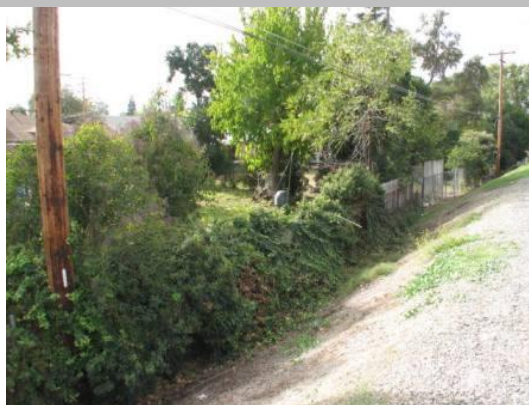
Photo 1 of 1 : SP_2016_NA0001_51_8_20160229_00007.jpg

LM Start	1.85	Rating **	M	Issue No.	8
LM End	1.85	Issue Type +	En	Location *	LS
Category	Earthen Levee			GPS Latitude/Longitude	
				Start	End
Item	Vegetation			38.627889 °	38.627889 °
				-121.436638 °	-121.436638 °
DWR ID	DWR_NA0001_01_s _2012_8				
Comment Code					
V6 : Landscaping					
Inspector Comment					
Ivy, trees and other landscaping growing on a privacy fence are obstructing visibility.

11/17/2011 Landscaping vegetation growth on the fence is obstructive.

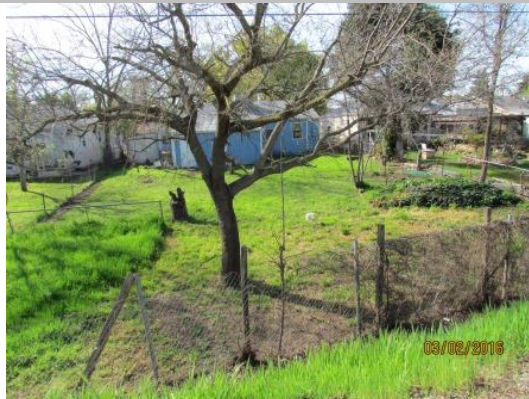
Photo 1 of 1 : SP_2016_NA0001_51_61_20160308_00084.jpg

LM Start	1.86	Rating **	M	Issue No.	61
LM End	1.86	Issue Type +	En	Location *	LS
Category	Earthen Levee			GPS Latitude/Longitude	
				Start	End
Item	Encroachments			38.627885 °	38.627885 °
				-121.436423 °	-121.436423 °
DWR ID	DWR_NA0001_01_f_2015_61				
Comment Code					
FE : Fence					
Inspector Comment					
Fence at landside levee toe.

View of the fence at the landside levee toe.

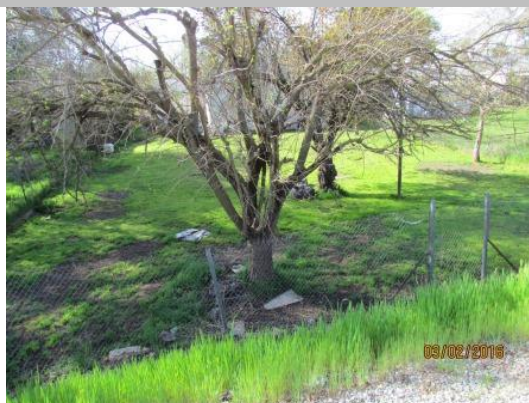
Photo 1 of 1 : SP_2016_NA0001_51_59_20160308_00083.jpg

LM Start	1.88	Rating **	M	Issue No.	59
LM End	1.88	Issue Type +	En	Location *	LS
Category	Earthen Levee			GPS Latitude/Longitude	
				Start	End
Item	Encroachments			38.627871 °	38.627871 °
				-121.436191 °	-121.436191 °
DWR ID	DWR_NA0001_01_f_2015_59				
Comment Code					
FE : Fence					
Inspector Comment					
Fence at landside levee toe.

View of the fence at the landside levee toe.

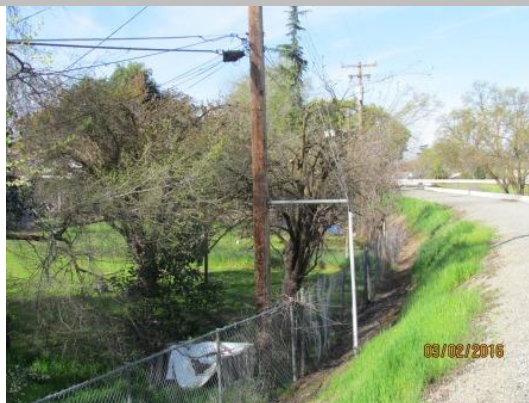
Photo 1 of 1 : SP_2016_NA0001_51_58_20160308_00082.jpg

LM Start	1.88	Rating **	M	Issue No.	58
LM End	1.88	Issue Type +	En	Location *	LS
Category	Earthen Levee			GPS Latitude/Longitude	
				Start	End
Item	Encroachments			38.627860 °	38.627860 °
				-121.436098 °	-121.436098 °
DWR ID	DWR_NA0001_01_f_2015_58				
Comment Code					
PO : Pole					
Inspector Comment					
Pole at the landside levee toe with guy wire penetrating the landside levee slope.

View of the pole at the landside levee toe.

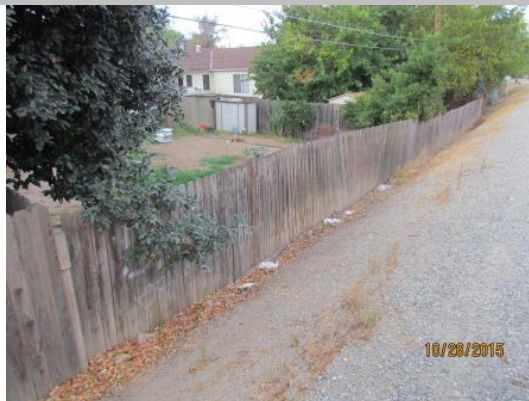
Photo 1 of 1 : SP_2016_NA0001_51_4_20160229_00003.jpg

LM Start	1.92	Rating **	U	Issue No.	4
LM End	1.92	Issue Type +	En	Location *	LS
Category	Earthen Levee			GPS Latitude/Longitude	
				Start	End
Item	Encroachments			38.627715 °	38.627715 °
				-121.435452 °	-121.435452 °
DWR ID	DWR_NA0001_01_s _ 2012_4				
Comment Code					
FE : Fence					
Inspector Comment					
Wooden fence and landscaping completely block visibility.

View of the wooden fence at the landside levee toe.

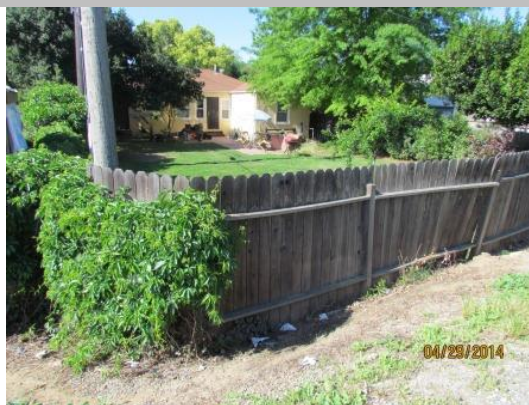
Photo 1 of 1 : SP_2016_NA0001_51_3_20160229_00002.jpg

LM Start	1.93	Rating **	U	Issue No.	3
LM End	1.93	Issue Type +	En	Location *	LS
Category	Earthen Levee			GPS Latitude/Longitude	
				Start	End
Item	Encroachments			38.627658 °	38.627658 °
				-121.435192 °	-121.435192 °
DWR ID	DWR_NA0001_01_s _ 2012_3				
Comment Code					
FE : Fence					
Inspector Comment					
Dog-eared wooden fence is built against the levee slope.

View of the fence at the landside levee toe.

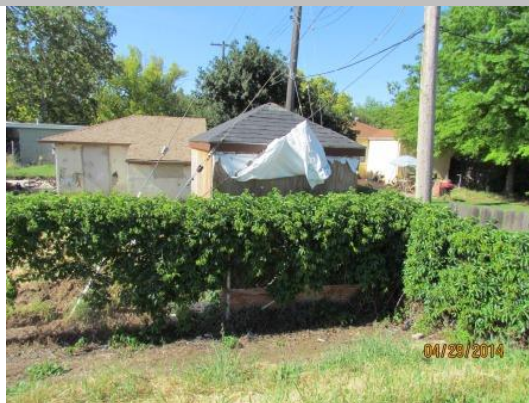
Photo 1 of 1 : SP_2016_NA0001_51_30_20160229_00024.jpg

LM Start	1.93	Rating **	U	Issue No.	30
LM End	1.93	Issue Type +	En	Location *	LS
Category	Earthen Levee			GPS Latitude/Longitude	
				Start	End
Item	Encroachments			38.627646 °	38.627646 °
				-121.435151 °	-121.435151 °
DWR ID	DWR_NA0001_01_s _ 2012_30				
Comment Code					
BU : Building					
Inspector Comment					
Concrete pad and wooden frame structure is being built within 15-ft of levee toe.

Building on concrete pad within 15 feet of the landside levee toe.

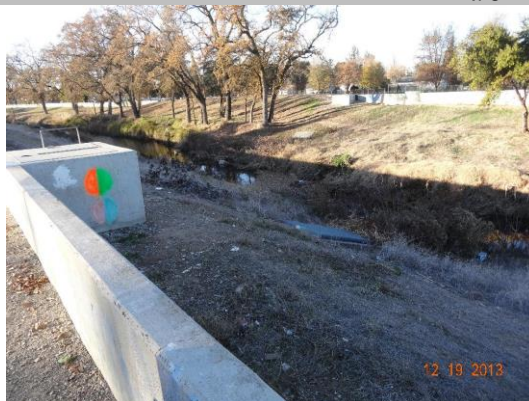
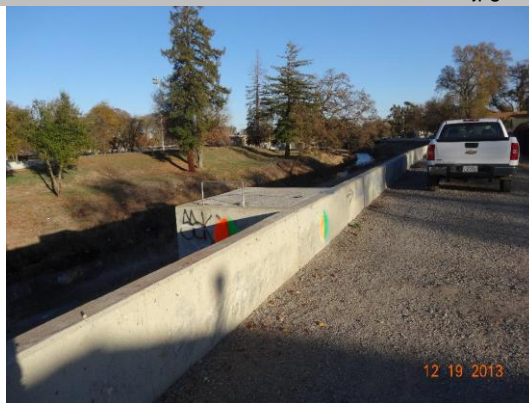
LM Start	1.95	Rating **	M	Issue No.	193
LM End	1.95	Issue Type +	En	Location *	LS
Category	Supplemental			GPS Latitude/Longitude	
				Start	End
Item	DWR UCIP Field Study			38.627568 °	38.627568 °
				-121.434815 °	-121.434815 °
DWR ID					
Comment Code					
Inspector Comment					
FS_ID:41549					
DS_ID:24259					
EP_NO: N/A					
Repair Type: Non-Urgent					
Crossing Status: Found					
UCIP Comments: 1/29/14 approximate alignment of crossings was provided by the City of Sacramento for known crossings through levee. Unable to confirm last inspection. Also City records indicate 10-inch not 15-inch--need to clarify with owner. Crossing is operational.					
FIELD_STRUCT_DESC: 15-inch pipe through the levee, 8.5 feet below the crown. Flap gate on the waterside (WS) end.					
FS Date: 12/19/2013

View of waterward side--concrete vault and u-shape concrete headwall with debris screen.

View of floodwall along waterward side.

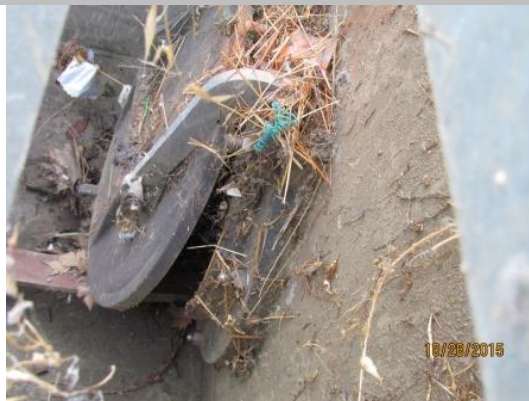
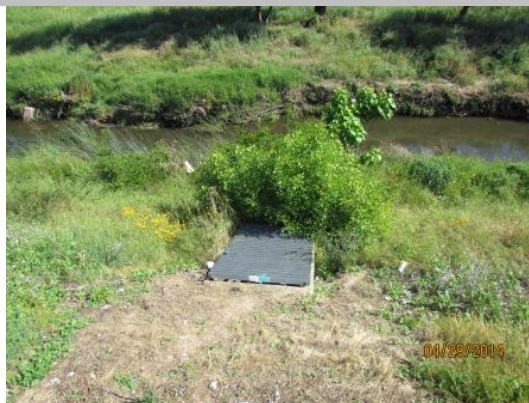
LM Start	1.95	Rating **	M	Issue No.	168
LM End	1.95	Issue Type +	En	Location *	WS
Category	Earthen Levee			GPS Latitude/Longitude	
				Start	End
Item	Encroachments			38.627565 °	38.627565 °
				-121.434818 °	-121.434818 °
DWR ID	DWR_NA0001_01_s _ 2012_168				
Comment Code					
PI : Pipe					
Inspector Comment					
Flap gate is blocked by debris in the outfall structure. Gate is blocked in the open position.

View of the flap gate propped open by debris.

View of the vegetation obstructing the outfall.

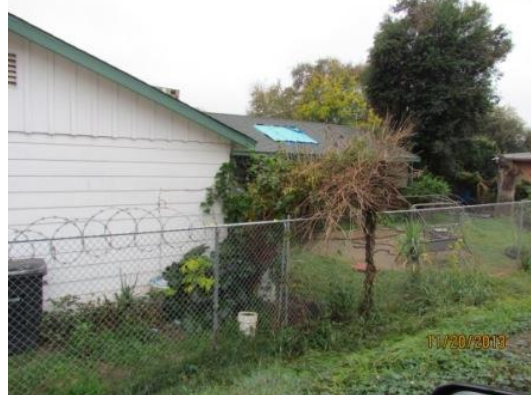
Photo 1 of 1 : SP_2016_NA0001_51_1_20160229_00001.jpg

LM Start	1.99	Rating **	M	Issue No.	1
LM End	1.99	Issue Type +	En	Location *	LS
Category	Earthen Levee			GPS Latitude/Longitude	
				Start	End
Item	Vegetation			38.627318 °	38.627318 °
				-121.434208 °	-121.434208 °
DWR ID	DWR_NA0001_01_s_2012_1				
Comment Code					
V6 : Landscaping					
Inspector Comment					
Vine growing on fence and slope blocks visibility.

View of the fence and landscaping at the landside levee toe.

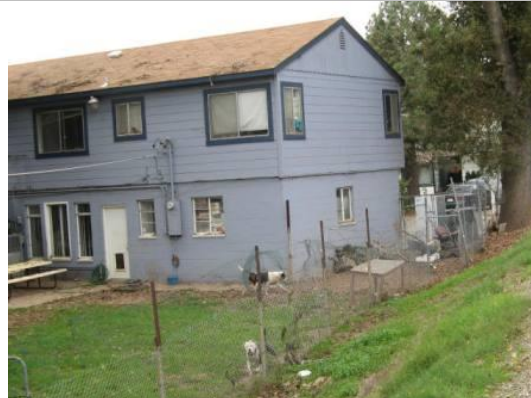
Photo 1 of 1 : SP_2016_NA0001_51_29_20160229_00023.jpg

LM Start	2.02	Rating **	U	Issue No.	29
LM End	2.02	Issue Type +	En	Location *	LS
Category	Earthen Levee			GPS Latitude/Longitude	
				Start	End
Item	Encroachments			38.627292 °	38.627292 °
				-121.433709 °	-121.433709 °
DWR ID	DWR_NA0001_01_s_2012_29				
Comment Code					
BU : Building					
Inspector Comment					
Two-story home foundation is within 10-ft of levee toe. Chain link fence is built on levee toe.

11/17/2011 Building foundation is within 15' of the levee toe.

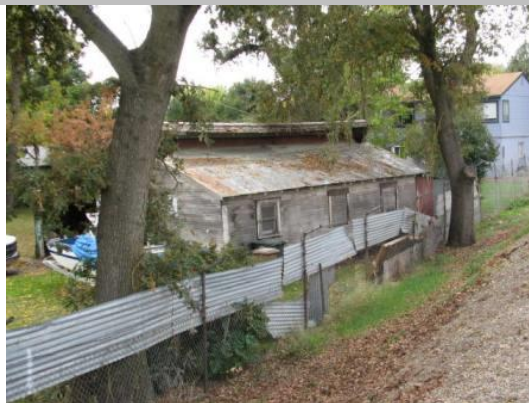
Photo 1 of 1 : SP_2016_NA0001_51_28_20160229_00022.jpg

LM Start	2.04	Rating **	U	Issue No.	28
LM End	2.04	Issue Type +	En	Location *	LS
Category	Earthen Levee			GPS Latitude/Longitude	
				Start	End
Item	Encroachments			38.627257 °	38.627257 °
				-121.433327 °	-121.433327 °
DWR ID	DWR_NA0001_01_s_2012_28				
Comment Code					
BU : Building					
Inspector Comment					
Large wooden building behind corrugated metal covered fence is within 10-ft of levee toe.

11/17/2011 Wooden structure is within 15' of the levee toe.

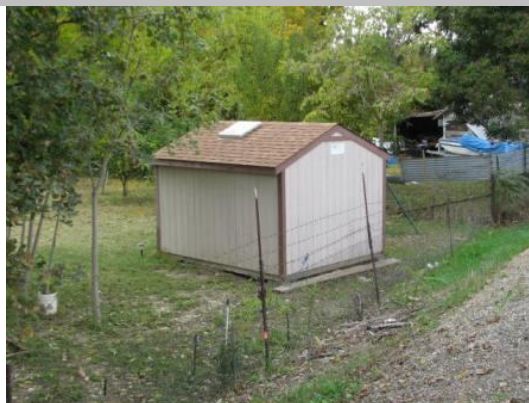
Photo 1 of 1 : SP_2016_NA0001_51_27_20160229_00021.jpg

LM Start	2.05	Rating **	M	Issue No.	27
LM End	2.05	Issue Type +	En	Location *	LS
Category	Earthen Levee			GPS Latitude/Longitude	
				Start	End
Item	Encroachments			38.627230 °	38.627230 °
				-121.433039 °	-121.433039 °
DWR ID	DWR_NA0001_01_s_2012_27				
Comment Code					
BU : Building					
Inspector Comment					
Pre-fab storage shed is within 10-ft of landside toe.

11/17/2011 Wooden structure is within 15' of the levee toe.

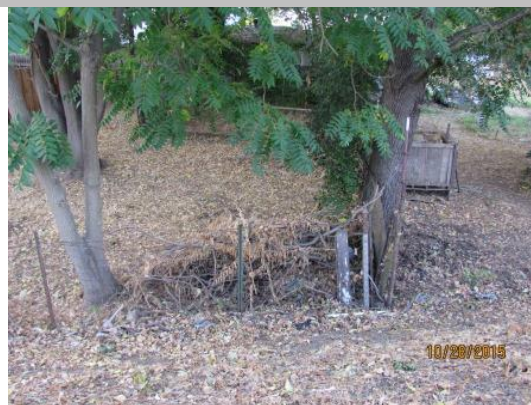
Photo 1 of 1 : SP_2016_NA0001_51_47_20160229_00030.jpg

LM Start	2.06	Rating **	M	Issue No.	47
LM End	2.06	Issue Type +	En	Location *	LS
Category	Earthen Levee			GPS Latitude/Longitude	
				Start	End
Item	Encroachments			38.627255 °	38.627255 °
				-121.432876 °	-121.432876 °
DWR ID	DWR_NA0001_01_f_2015_47				
Comment Code					
PR : Prunings					
Inspector Comment

View of the prunings at the landside levee toe.

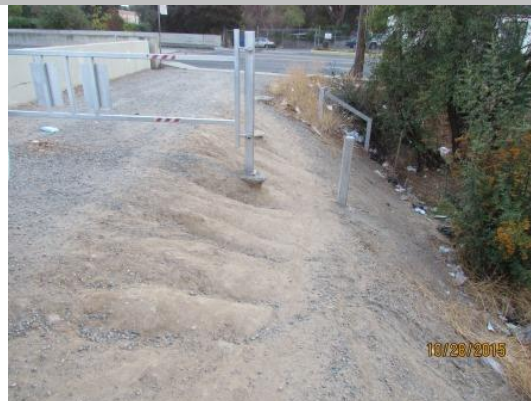
Photo 1 of 1 : SP_2016_NA0001_51_46_20160229_00029.jpg

LM Start	2.07	Rating **	M	Issue No.	46
LM End	2.07	Issue Type +	Ma	Location *	LS
Category	Earthen Levee			GPS Latitude/Longitude	
				Start	End
Item	Slope Stability			38.627246 °	38.627246 °
				-121.432673 °	-121.432673 °
DWR ID	DWR_NA0001_01_f_2015_46				
Comment Code					
S2 : Repair the levee slope damaged by foot traffic and prevent access where possible.					
Inspector Comment

View of the damaged landside levee slope.

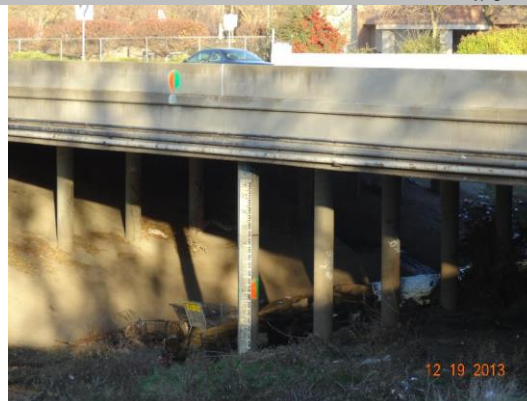
Photo 2 of 2 : UCIP_SP_2016_31185_57090.jpg

LM Start	2.08	Rating **	M	Issue No.	191 (cont)	
LM End	2.08	Issue Type +	En	Location *	LS	
Category	Supplemental			GPS Latitude/Longitude		
				Start		End
Item	DWR UCIP Field Study			38.627239 °		38.627239 °
				-121.432501 °		-121.432501 °
DWR ID						
Comment Code						
Inspector Comment						
FS_ID:31185 DS_ID:24420 EP_NO: 13044 Repair Type: Non-Urgent Crossing Status: Indicator Found UCIP Comments: Orange/Green symbol for flood structure found on floodwall. No crossing found. Need to determine if crossing is in use. This crossing is not shown in the City of Sacramento's sewer drain mains or water mains. Need to contact owner to determine if crossing is still in use. FIELD_STRUCT_DESC: 12-inch steel water main through the levee, 4.0 feet below the crown. (Permit No. 13044-1981) FS Date: 12/19/2013

Markers visible of crossing on bridge.

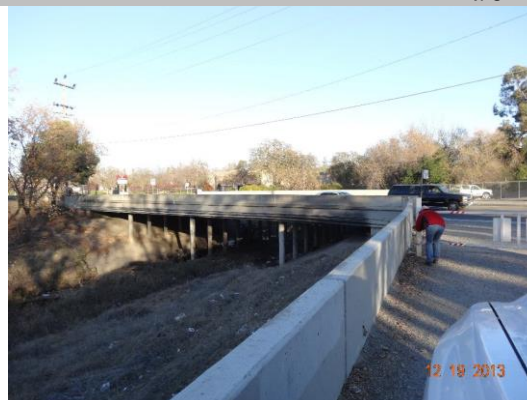
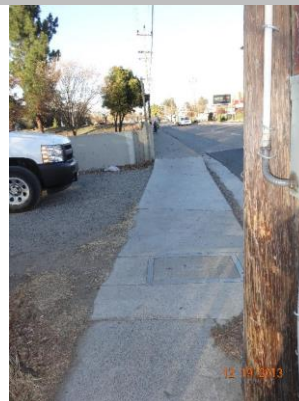
LM Start	2.08	Rating **	M	Issue No.	192
LM End	2.08	Issue Type +	En	Location *	LS
Category	Supplemental			GPS Latitude/Longitude	
				Start	End
Item	DWR UCIP Field Study			38.627242 °	38.627242 °
				-121.432469 °	-121.432469 °
DWR ID					
Comment Code					
Inspector Comment					
FS_ID:31424 DS_ID:24797 EP_NO: N/A Repair Type: Non-Urgent Crossing Status: Found UCIP Comments: no permit--need to determine additional information and owner of crossings. FIELD_STRUCT_DESC: 1-4 inch conduit and 1-2 inch communication cable through levee. Conduits are suspended through waterway and attached to downstream face of bridge. FS Date: 12/19/2013

View of waterward side--conduits visible on bridge face.

Service box located on sidewalk unable to determine if box belongs to conduits.

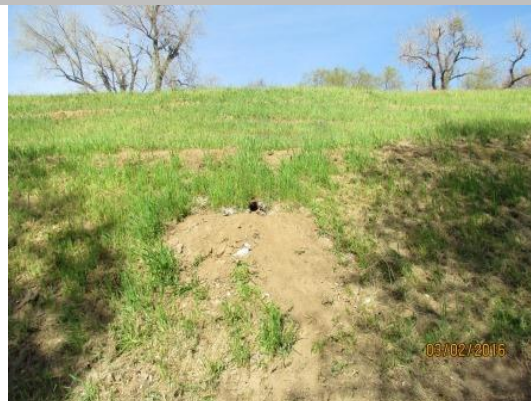
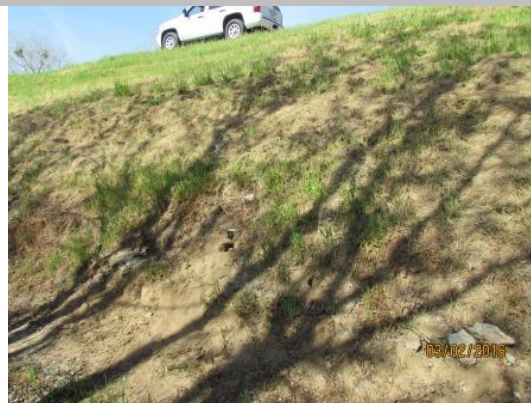
LM Start	0.09	Rating **	M	Issue No.	28 (cont)
LM End	0.10	Issue Type +	Ma	Location *	LS

View of the rodent holes on the landside levee slope.

Another view of the rodent holes on the landside levee slope.

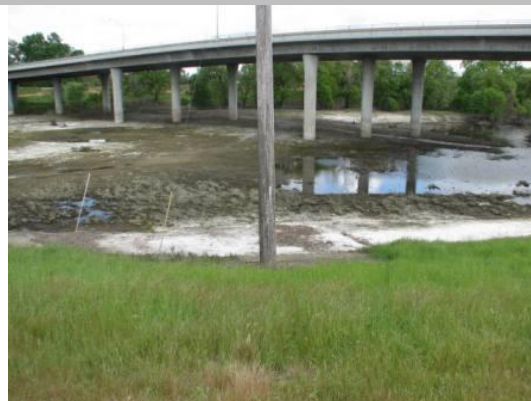
Photo 1 of 1 : SP_2016_NA0001_52_2_20160229_00001.jpg

LM Start	0.33	Rating **	M	Issue No.	2
LM End	0.33	Issue Type +	En	Location *	WS
Category	Earthen Levee			GPS Latitude/Longitude	
				Start	End
Item	Encroachments			38.605822 °	38.605822 °
				-121.468078 °	-121.468078 °
DWR ID	DWR_NA0001_02_s_2012_2				
Comment Code					
PO : Pole					
Inspector Comment					
Power pole in levee

04/13/2011 Power pole is in the levee on the water side.

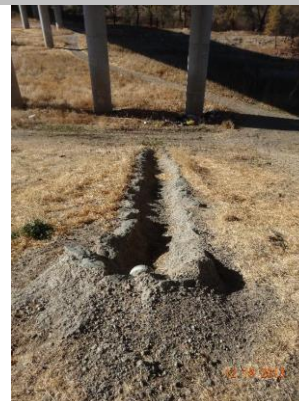
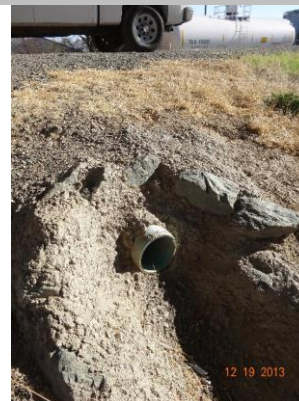
LM Start	0.36	Rating **	M	Issue No.	159
LM End	0.36	Issue Type +	En	Location *	WS
Category	Supplemental			GPS Latitude/Longitude	
				Start	End
Item	DWR UCIP Field Study			38.606204 °	38.606204 °
				-121.467817 °	-121.467817 °
DWR ID					
Comment Code					
Inspector Comment					
FS_ID:31443					
DS_ID:24798					
EP_NO: N/A					
Repair Type: Non-Urgent					
Crossing Status: Indicator Found					
UCIP Comments: no permit (unauthorize crossing)--need to determine additional information about crossing. Unable to determine if pipe crosses levee.					
FIELD_STRUCT_DESC: 4-inch HDPE pipe through levee at unknown depth.					
FS Date: 12/6/2013

View of waterward slope.

View of pipe through levee.
